# Seepage Induced Geotechnical Instability of Flood Embankments

*Workshop on seepage induced instability  
Imperial College, August 2017*

Dr Philip Smith  
31st August 2017

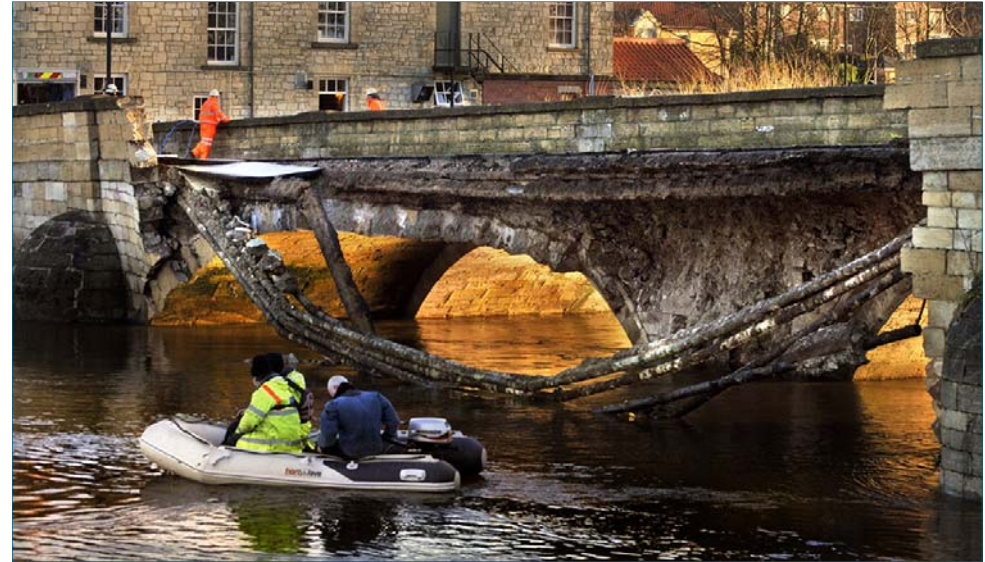
Tadcaster Bridge collapse, River Wharfe

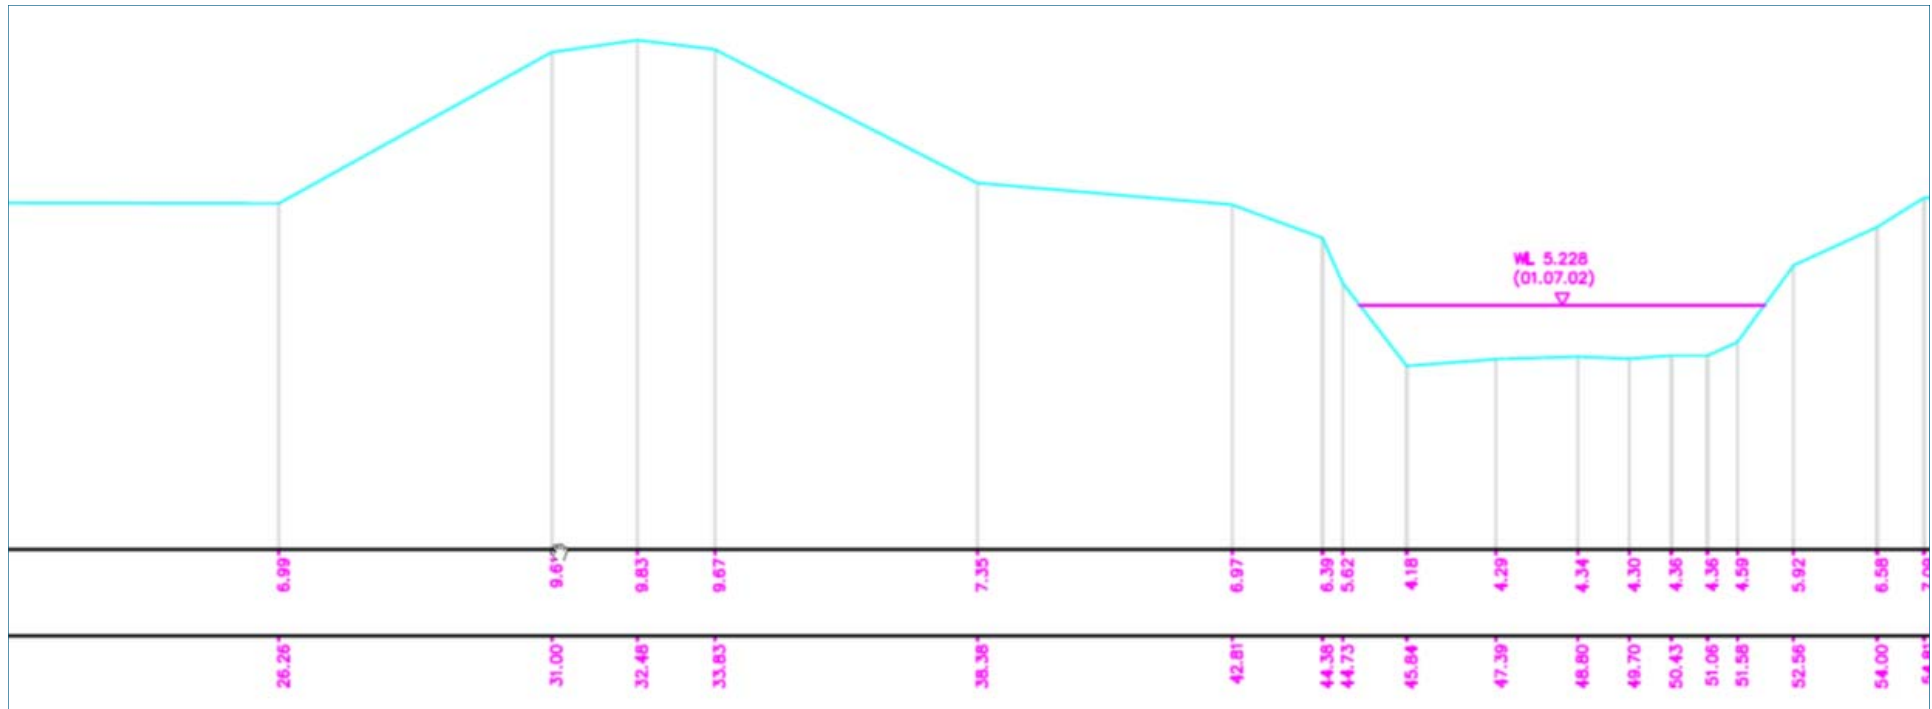
- c. 1V:1.75H (30°) landward slopes
- <3m wide crest
- 3m wide berm on riverward side

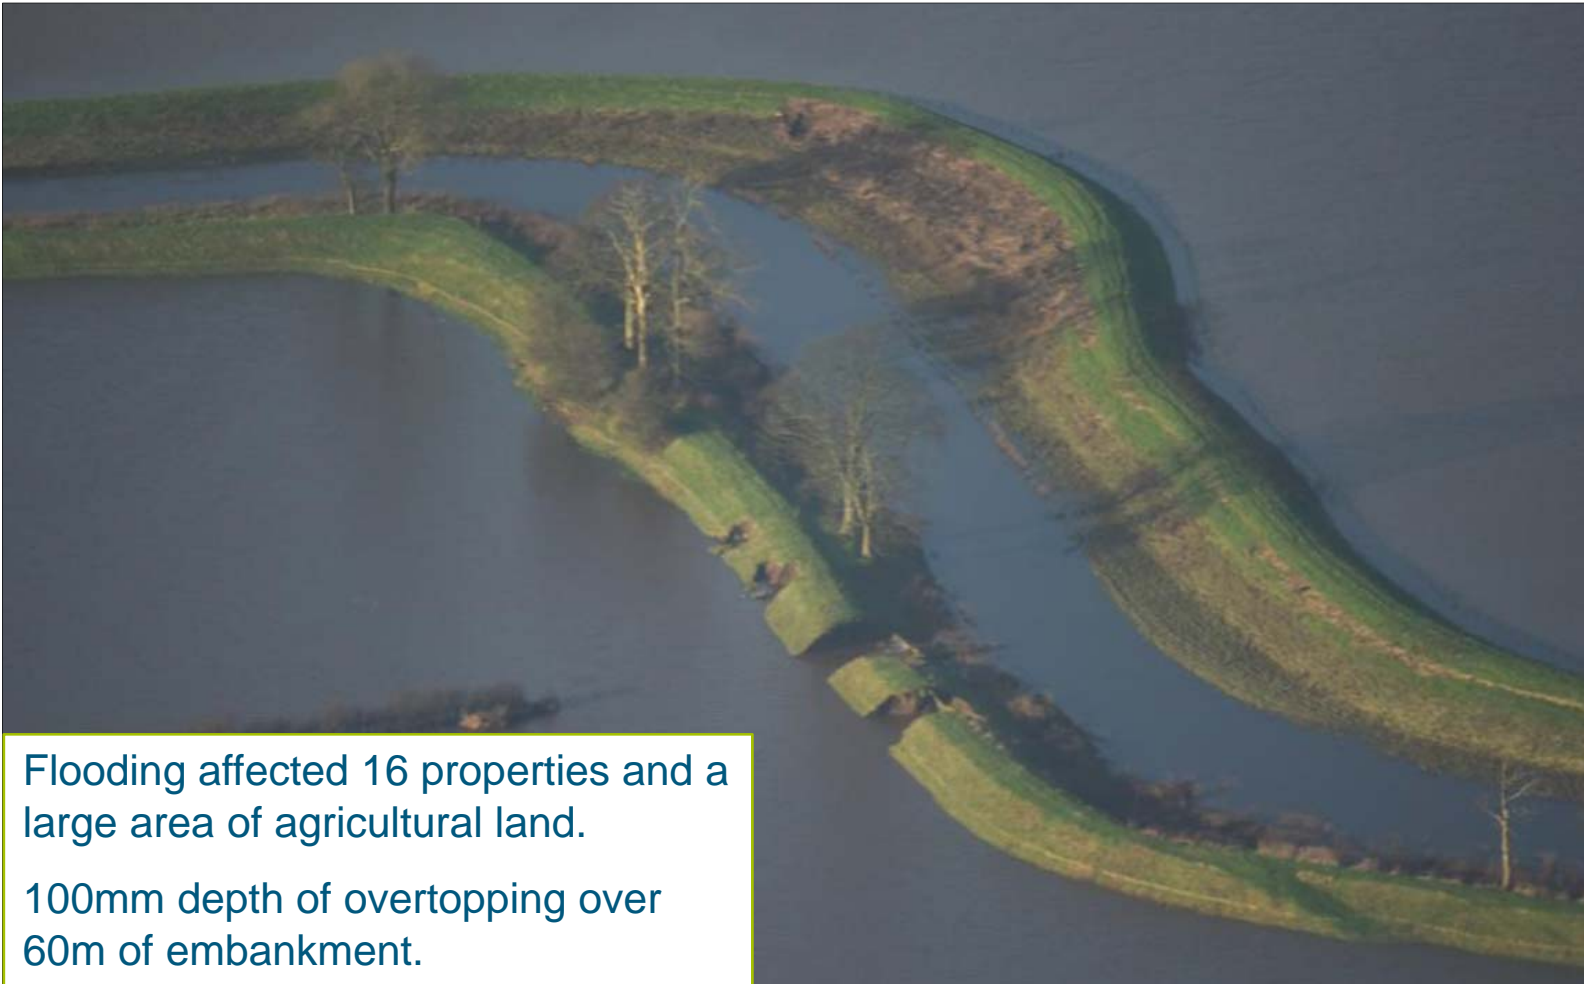
Flooding affected 16 properties and a large area of agricultural land.

100mm depth of overtopping over 60m of embankment.

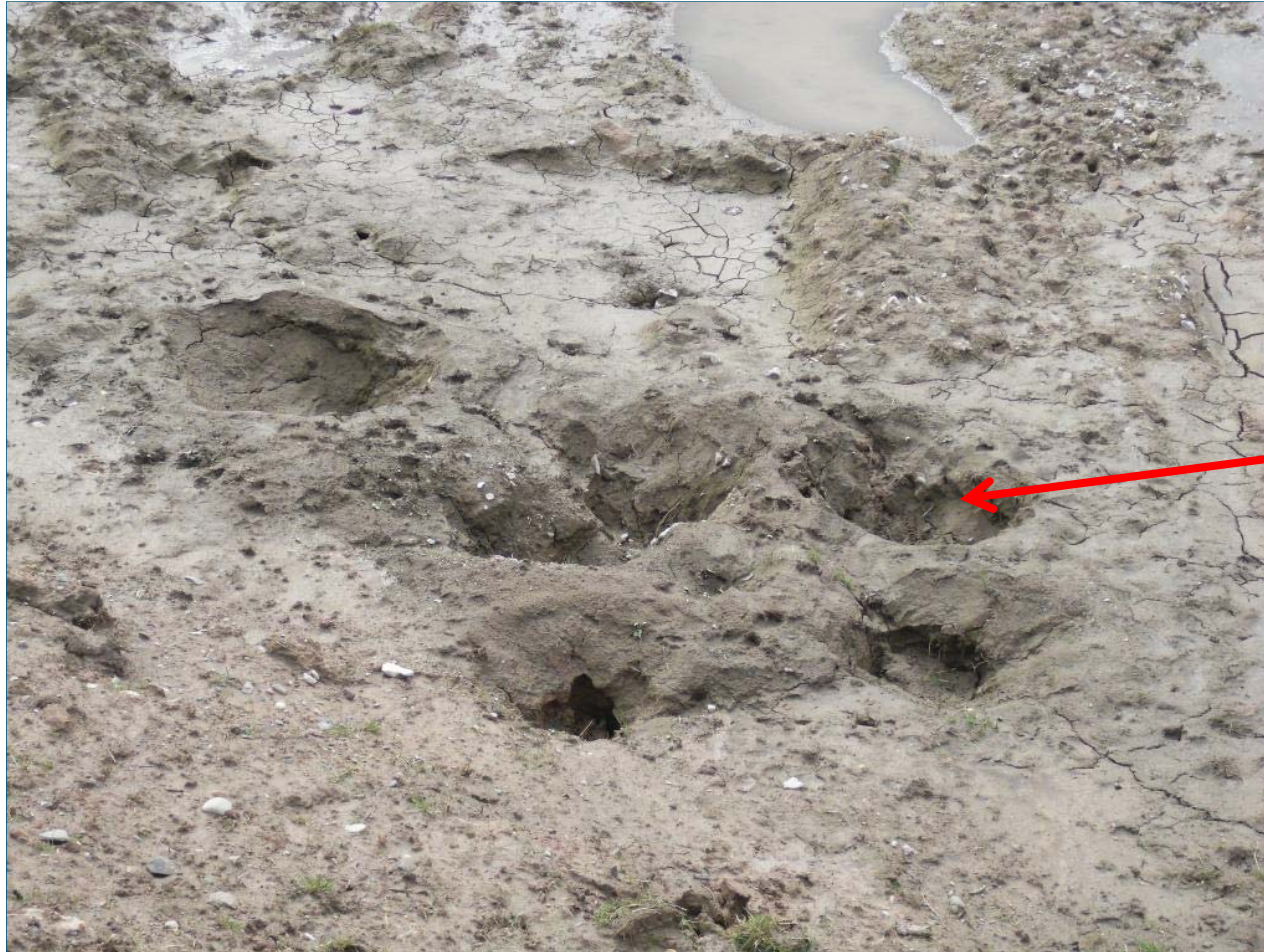
Evidence of piping  
on landward side  
of embankment at  
location of breach.

Coincides with  
location of historic  
land drain

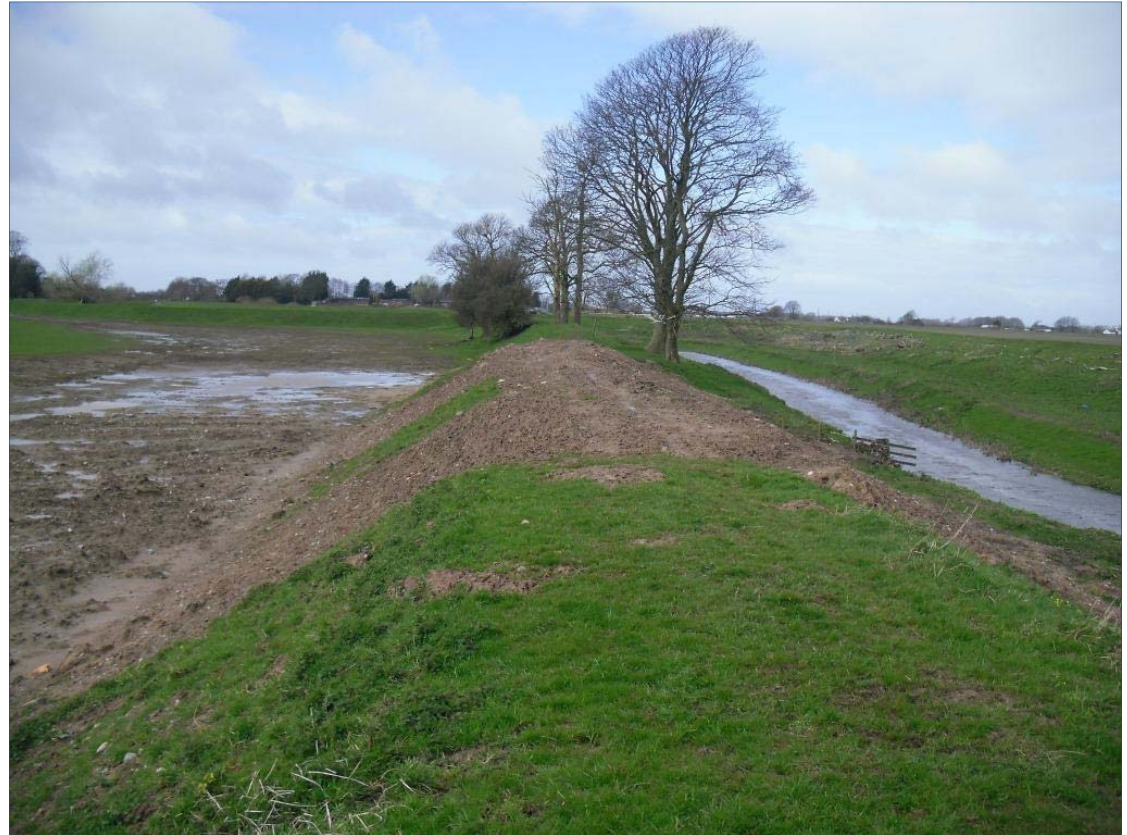
**Breach failure initiated by overtopping erosion of landward slope**

1. Localised low crest leading to overtopping.
2. Reduction in toe resistance caused by possible piping at location of historic land drain.
3. Steep landward slope;
4. Relatively poor quality embankment fill material.

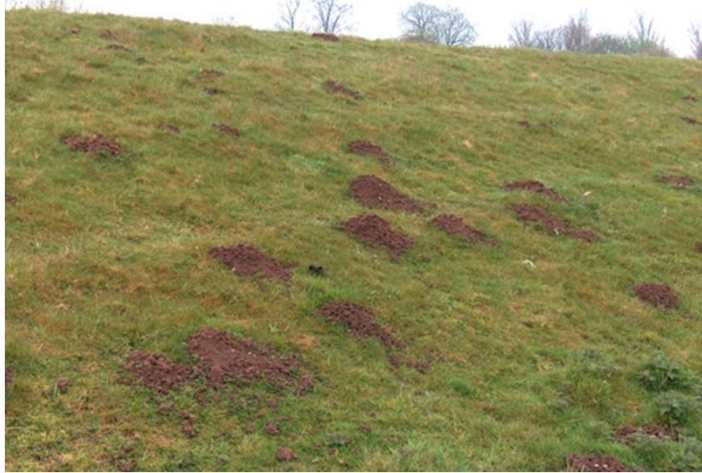
**Rabbit burrowing, Scotland**

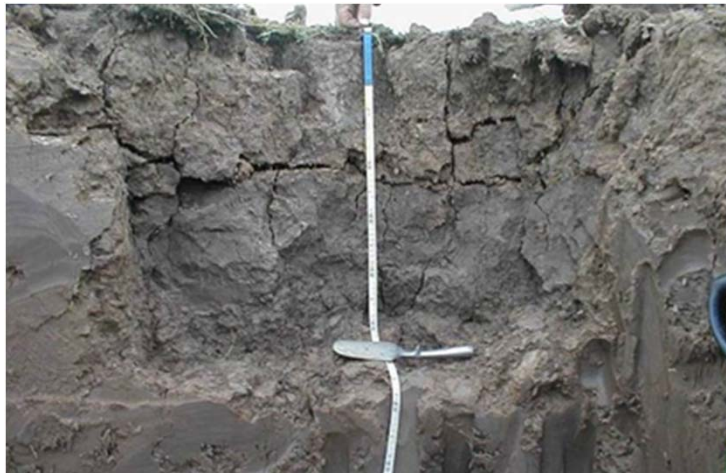
**Desiccation cracking of clay embankment**

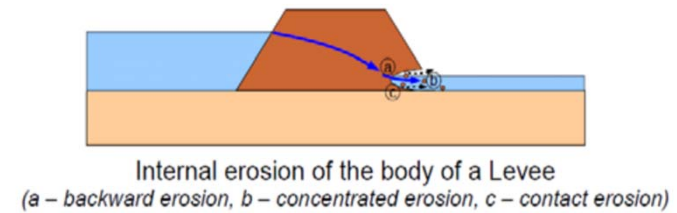
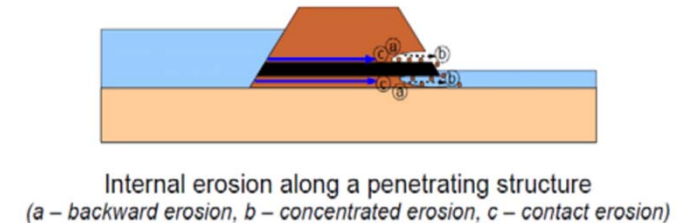
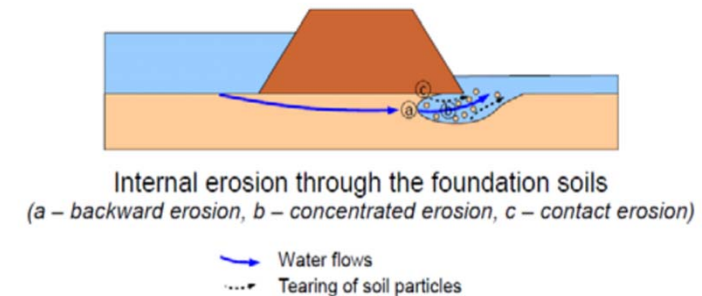
**Ongoing and cumulative effects of seepage and internal erosion**

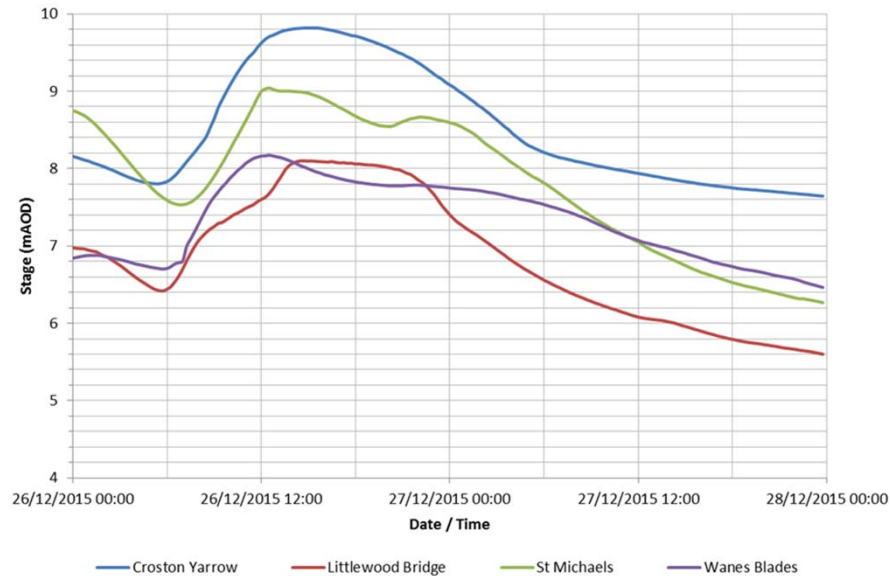
**Croston, Lancashire,  
December 2015**

**Flood duration 1 day**

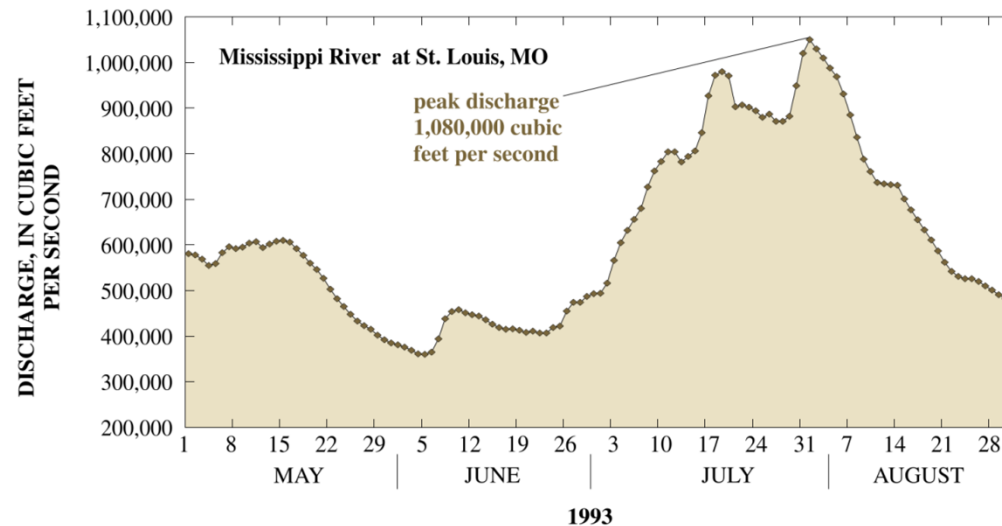
**Mississippi River, St  
Louis, 1993**

**Flood duration 2 months**
