The Non-destructive Testing of Adhesive Joints for Environmental Degradation

A thesis submitted for the degree of Doctor of Philosophy of the
University of London.

Department of Mechanical Engineering

Imperial College of Science Technology and Medicine

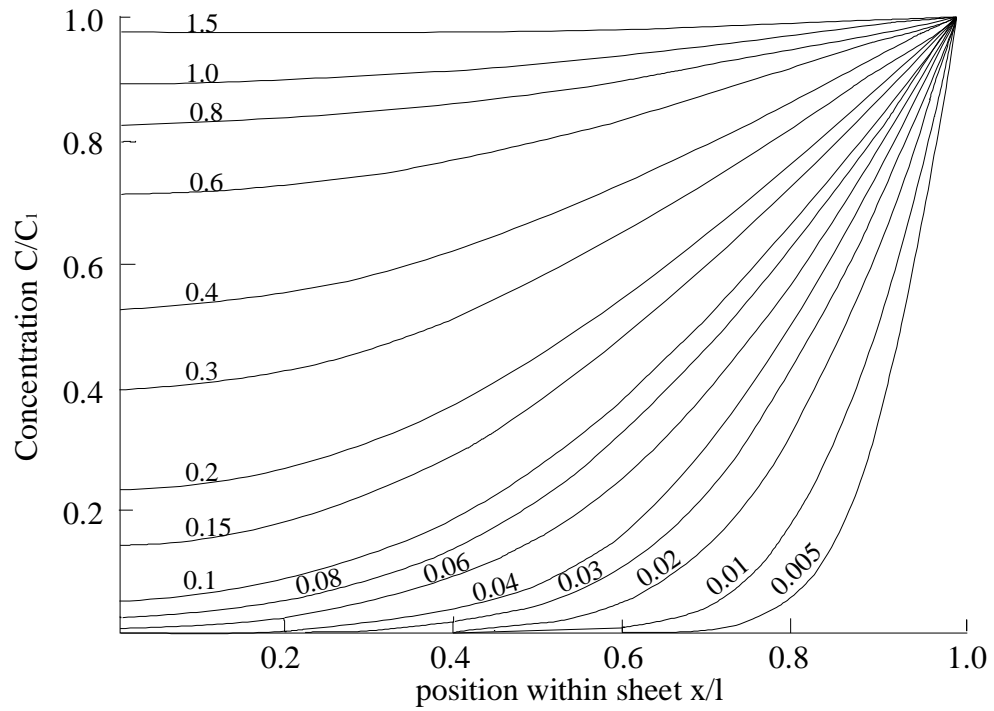
Figure 2.6 Water concentration distribution curves for one-dimensional diffusion of water into adhesive sheet, numbers on curves represent values of Dt/l^2 where D is the diffusion coefficient, t is time and l is the diffusion length [34].

smallest value of Dt/l^2 taken from Figure 2.6, as this shows the distribution of water in

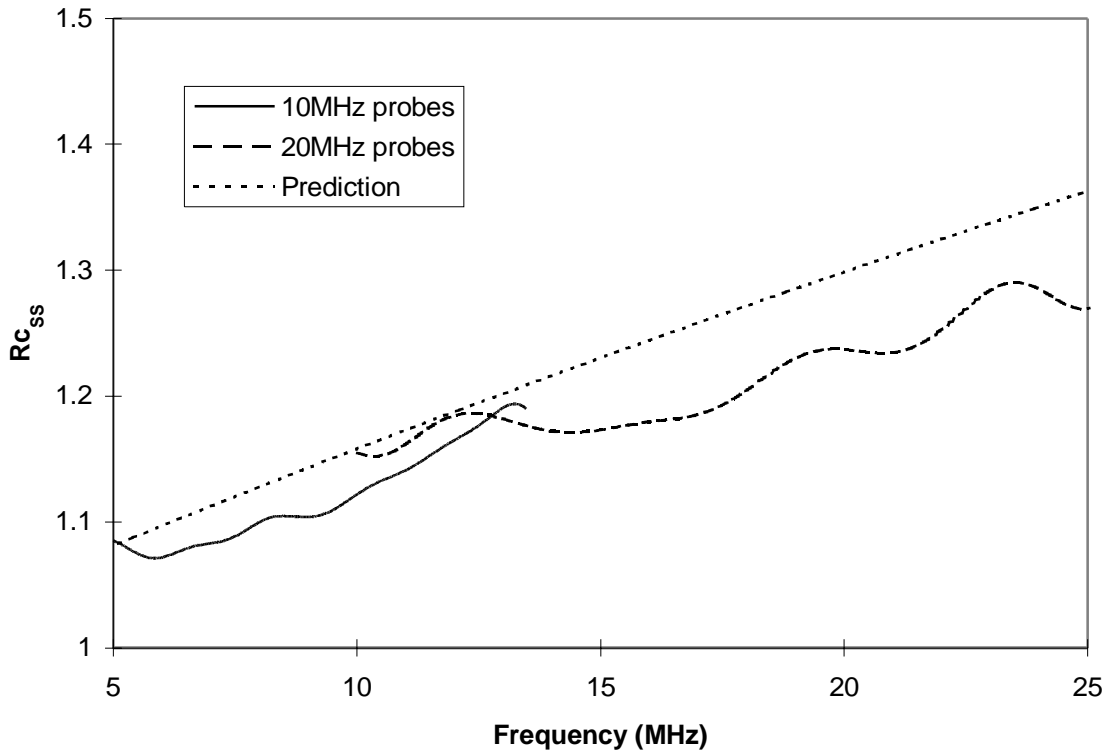
used by Pialucha and have shown reasonable agreement with his experimental curves using 10MHz transducers. These measurements are shown in Figure 2.13 along with the predicted reflection coefficient for a 5 μ m thick oxide layer with the same properties as used for the previous oblique incidence reflection coefficient predictions. In this case the thickness of the oxide layer was chosen to fit the experimental results. This figure shows good agreement, both for the continuity of results obtained by Pialucha and also for the agreement with theory. This shows that doubling the frequency doubles the difference in reflection coefficient obtained compared to the case of no oxide being present. (All of the results shown are normalised with respect to a bare aluminium/epoxy interface, hence the appearance of $R_{C_{SS}} > 1$.)

Figure 2.13 SS reflection coefficient measurement at 32° from one of Pialucha's specimens, showing measurements made with 10MHz and 20MHz probes along with predicted frequency response for a 5 μ m oxide layer.

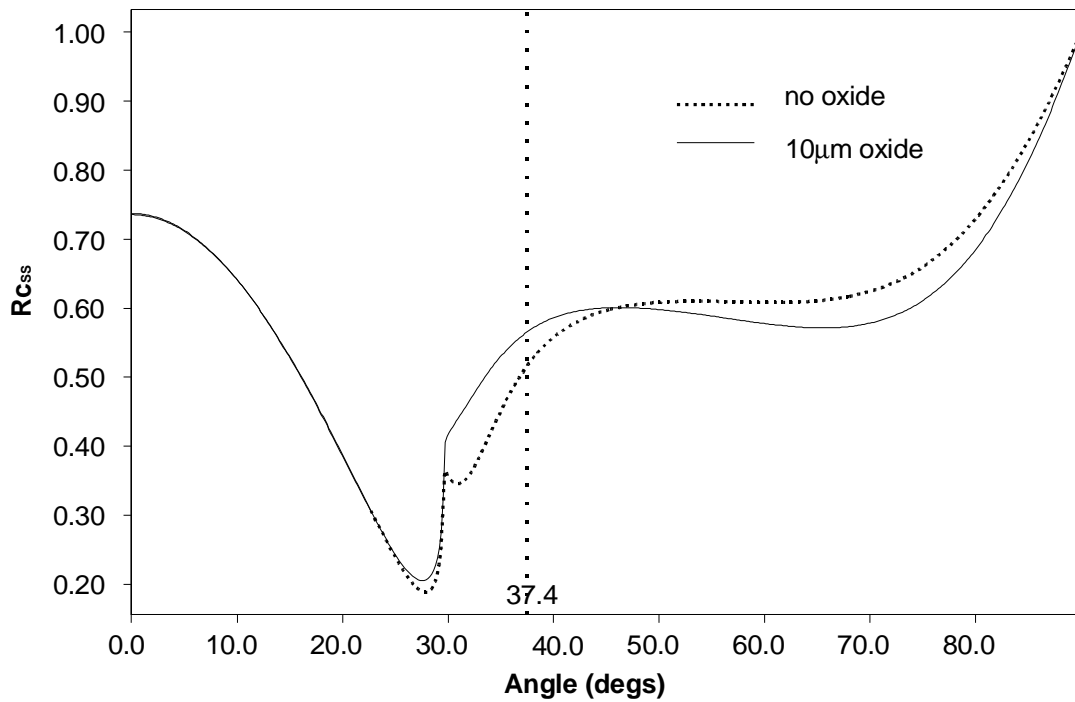
Figure 2.19 Variation of SS reflection coefficient with angle for the case with a $1\mu\text{m}$ oxide layer compared with the case for no oxide layer, showing angle chosen for oblique incidence scans.

The probes used to validate the idea of using focused probes to reduce the sensitivity to misalignment were 10MHz with a focal length of 75mm and an element diameter of 9mm. These probes will result in a range of angles being incident on the surface of the aluminium. If we continued to use a 32° shear wave angle then some of the waves from the transducer would be incident below the longitudinal critical angle. From these curves it was decided that an angle of 37.4° shear in aluminium was most suitable, as shown in Figure 2.19.

This gives good sensitivity to the presence of the oxide layer, but moves the angle a little further away from the longitudinal critical angle. This ensures that small changes in alignment during scanning will not result in the appearance of any LL or SL+LS reflections, thus giving more complicated time domain signals. The probable interference between mode converted signals would make scanning very difficult, certainly for 3 layer specimens, where the bondline thickness is around 0.3mm. It is also desirable for the angle to be as near to normal as possible in order to produce a sharp focal zone; if the angle of incidence is too oblique then the focal spot becomes very elongated, giving poorer resolution scans. The specimen design used also meant that there would be the possibility of water moving along the interface of the specimen and so predictions were made to determine the sensitivity of this probe arrangement for the detection of a thin water layer.

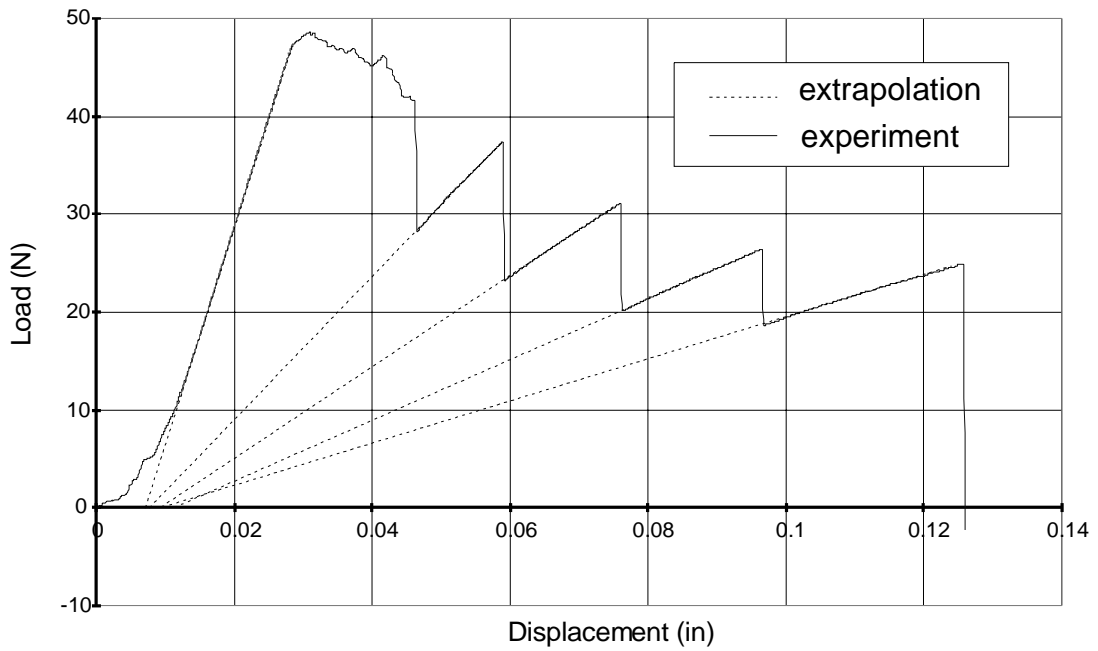
Figure 2.25 Load displacement graph from mechanical test of three-layer specimen, extrapolation of curve back to zero load shown for a number of position during crack arrest.

Figure 2.25 shows the load displacement graph obtained from a three-layer mechanical test. At several points during this test the crack stopped growing, and a linear increase in the load was observed. These linear portions of the curve have been extrapolated back to zero load, and these all show near identical displacements at zero load. (This displacement being the slack in the shackles at the start of the test.) This shows that there has been no plastic bending of the adherends during the test, allowing (2.8) to be used.
